---

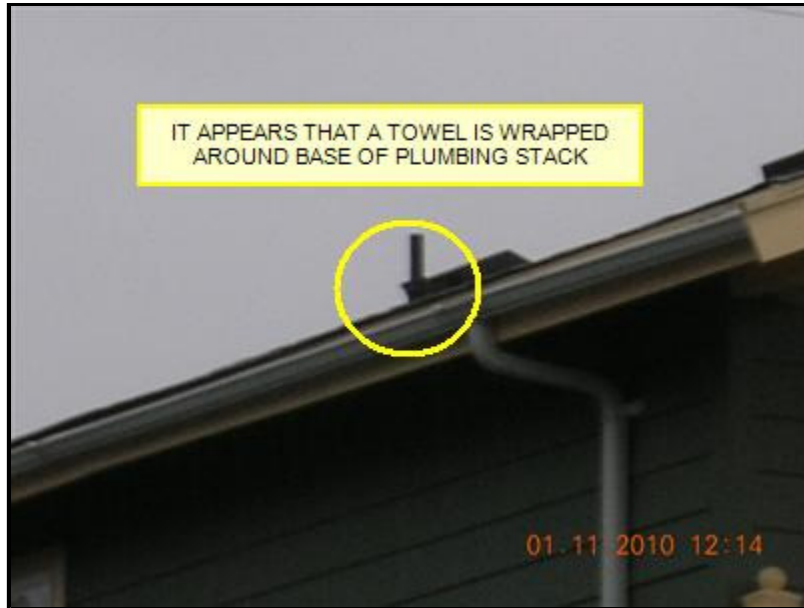
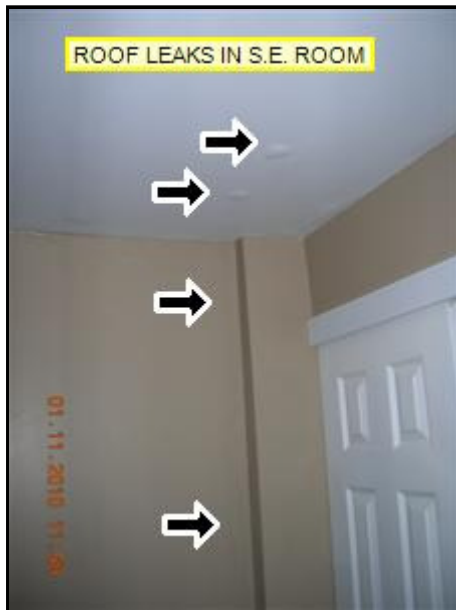
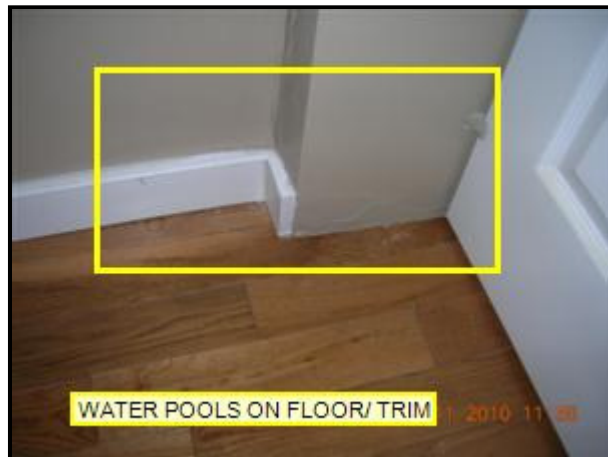
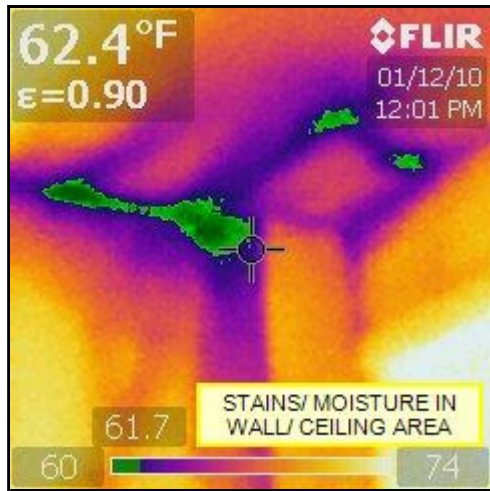
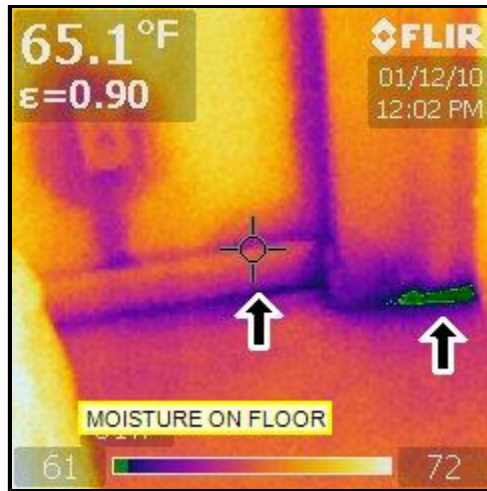
**1.0** ROOF LEAKS AT THE S.E. AREA INTO MASTER BEDROOM. WATER POOLING/ LEAKING THROUGH CEILING AND DOWN WALL AT TIME OF INSPECTION. NOTE THAT IT APPEARS A TOWEL HAS BEEN WRAPPED AROUND BASE OF PLUMBING STACK; RECOMMEND A LICENSED ROOFER TO EVALUATE/ REPAIR LEAK- CHECK SURROUNDING CONSTRUCTION FOR WATER DAMAGE AT TIME OF REPAIR.

ROOF LEAKS AT THE S.E. AREA INTO MASTER BEDROOM. WATER POOLING/ LEAKING THROUGH CEILING AND DOWN WALL AT TIME OF INSPECTION. NOTE THAT IT APPEARS A TOWEL HAS BEEN WRAPPED AROUND BASE OF PLUMBING STACK; RECOMMEND A LICENSED ROOFER TO EVALUATE/ REPAIR LEAK- CHECK SURROUNDING CONSTRUCTION FOR WATER DAMAGE AT TIME OF REPAIR.

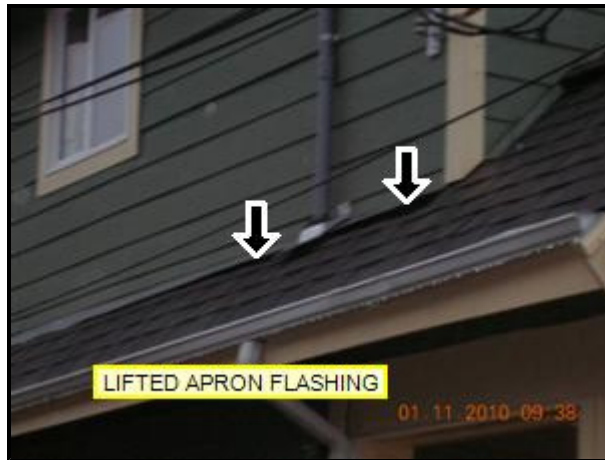
1.1 Picture 1

**1.1** N.W. LOWER APRON FLASHING AND STORM BOOT FLASHING TO SERVICE MAST IS LIFTING; SECURE LIFTED FLASHING FLUSH TO ROOF- CONSULT A QUALIFIED ROOFER TO REPAIR.

N.W. LOWER APRON FLASHING AND STORM BOOT FLASHING TO SERVICE MAST IS LIFTING; SECURE LIFTED FLASHING FLUSH TO ROOF- CONSULT A QUALIFIED ROOFER TO REPAIR.

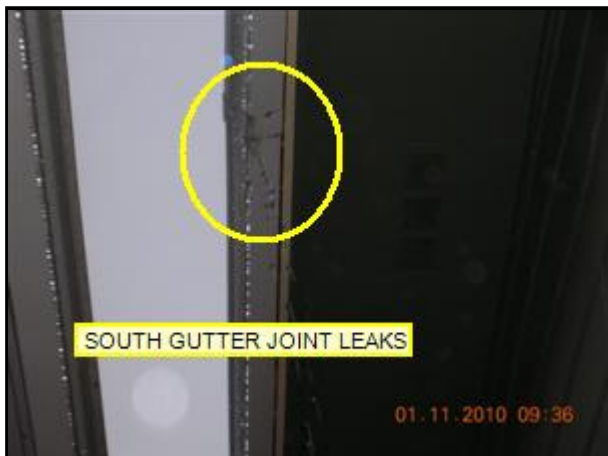
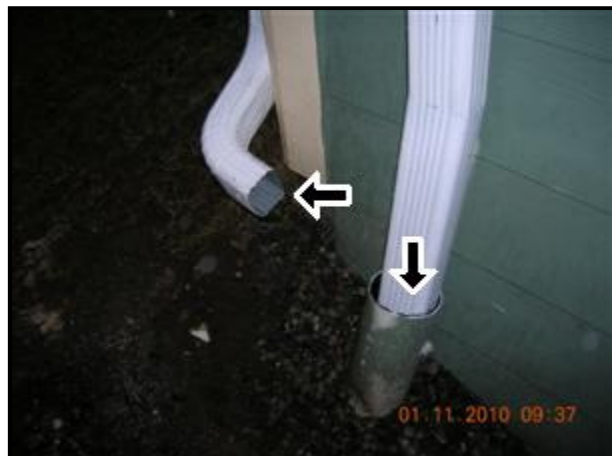
**1.4** SOUTH GUTTER JOINT LEAKS, THE S.W. DOWN SPOUT DOES NOT TIE IN WITH THE EXISTING IN-GROUND DRAIN LINE; RECOMMEND REPAIRING LEAKY GUTTER, INSTALL A DRAIN TIE AND EXTENSION TO DOWN SPOUT.

**12.1** LEAKY SOUTH GUTTER NOTED; REPAIR.

SOUTH GUTTER JOINT LEAKS, THE S.W. DOWN SPOUT DOES NOT TIE IN WITH THE EXISTING IN-GROUND DRAIN LINE; RECOMMEND REPAIRING LEAKY GUTTER, INSTALL A DRAIN TIE AND EXTENSION TO DOWN SPOUT.

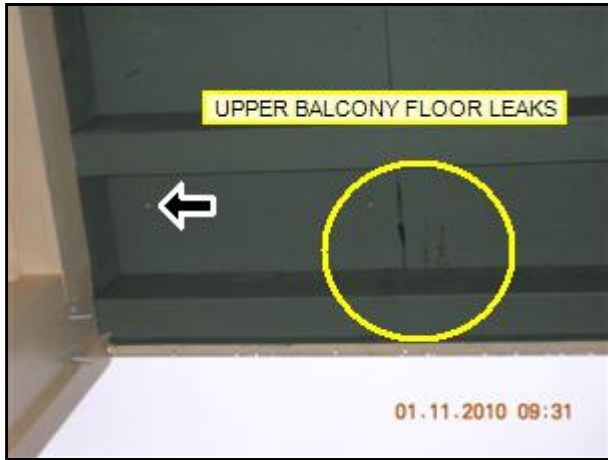
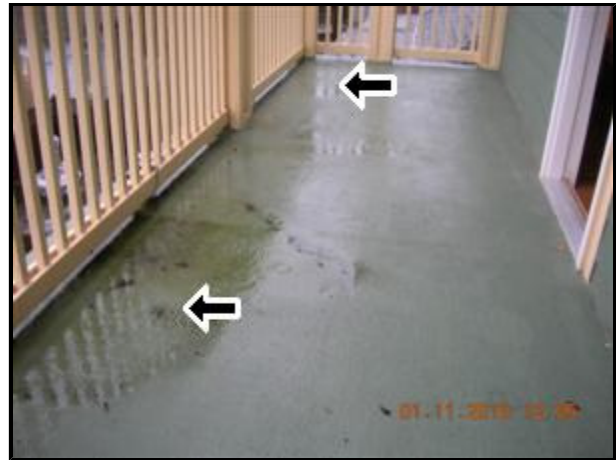
2.3 (1) UPPER S.E. BALCONY FLOOR POOLS WATER/ LEAKS- DRIPPING AT TIME OF INSPECTION THROUGH WOOD FLOORING; RECOMMEND A QUALIFIED SPECIALIST TO REPAIR/ RE-COAT DECKING AS NEEDED.

**12.4** EAST UPPER BALCONY LEAKS THROUGH FLOOR DUE TO POOLING; REPAIR/ RE-COAT DECKING.

(1) UPPER S.E. BALCONY FLOOR POOLS WATER/ LEAKS- DRIPPING AT TIME OF INSPECTION THROUGH WOOD FLOORING; RECOMMEND A QUALIFIED SPECIALIST TO REPAIR/ RE-COAT DECKING AS NEEDED.

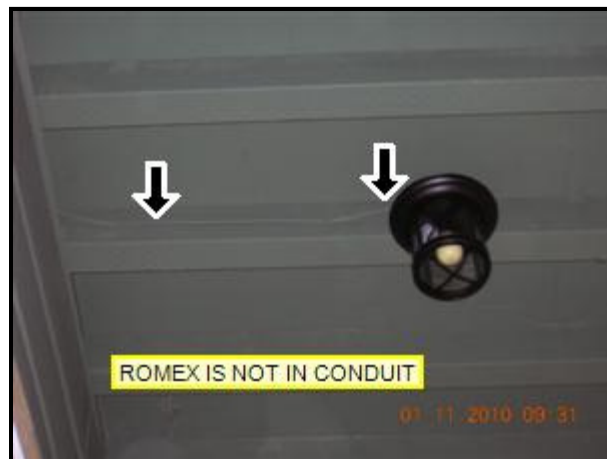
2.8 Picture 1

**2.8** ROMEX WIRING TO BALCONY LIGHTS IS NOT IN PROPER OUTDOOR CONDUIT; INSTALLATION RECOMMENDED FOR SAFETY BY A LICENSED ELECTRICIAN.

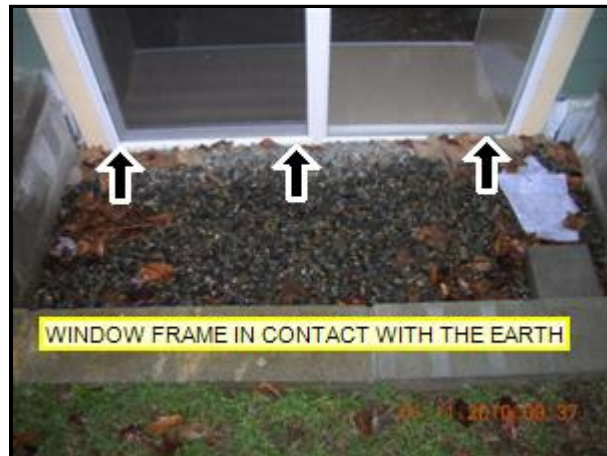
2.11 Picture 1

**2.11** S.W. WINDOW FRAME IS IN CONTACT WITH SOIL; GRADE SOIL A MINIMUM OF 4"6" BELOW BOTTOM OF FRAME TO PREVENT DAMAGE.

S.W. WINDOW FRAME IS IN CONTACT WITH SOIL; GRADE SOIL A MINIMUM OF 4"6" BELOW BOTTOM OF FRAME TO PREVENT DAMAGE.

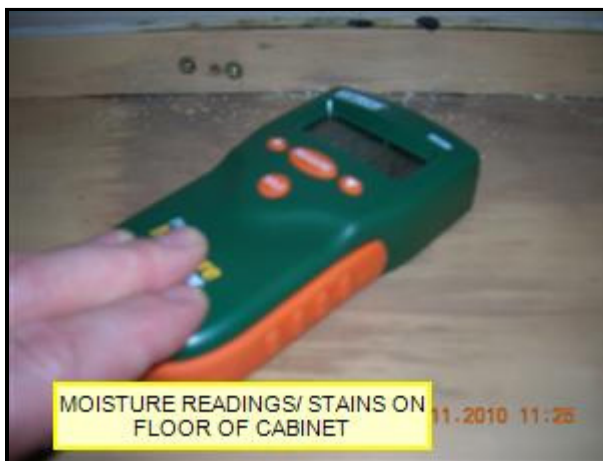
4.10 Picture 1

**4.10** HIGH MOISTURE READINGS AND STAINS ON FLOOR OF CABINET IN LOWER BATHROOM- APPEARS CAUSED BY LEAKY HOT VALVE; REPAIR LEAK/ MONITOR FOR FUTURE WATER LEAKAGE.

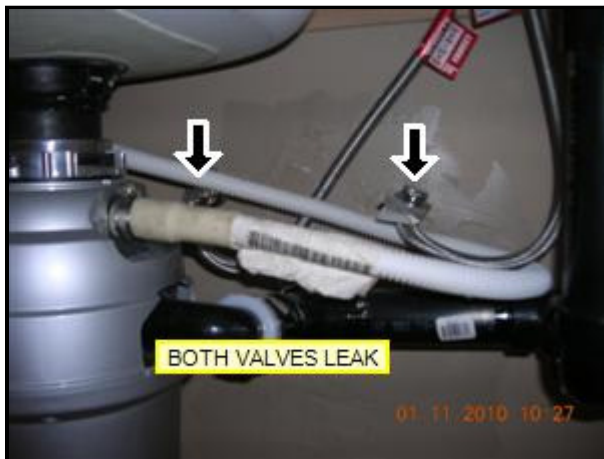
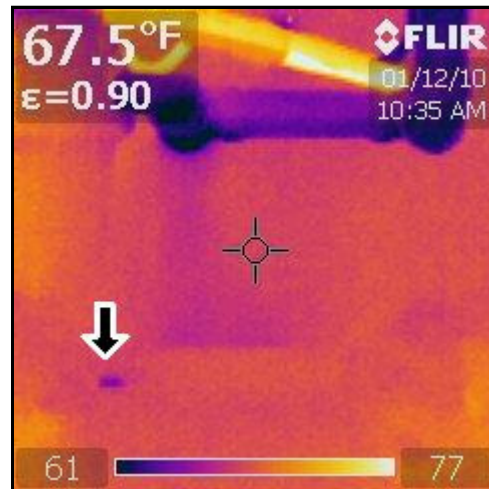
**5.0** (1) HOT/ COLD VALVES BOTH LEAK AT FITTINGS; RECOMMEND A LICENSED PLUMBER TO REPAIR LEAKS.

(1) HOT/ COLD VALVES BOTH LEAK AT FITTINGS; RECOMMEND A LICENSED PLUMBER TO REPAIR LEAKS.

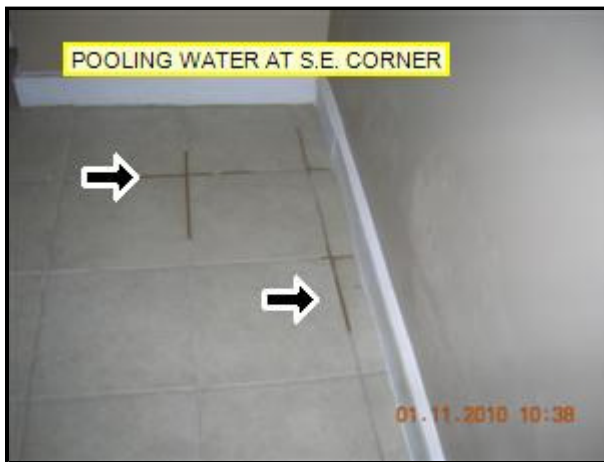
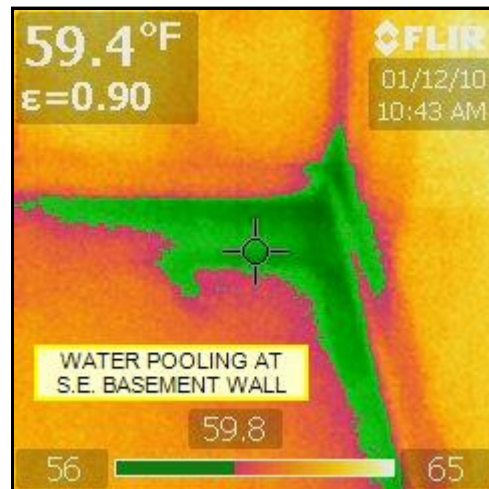
**7.6 STANDING WATER DETECTED IN S.E. BASEMENT ALONG FOUNDATION WALL. IT IS UNKNOWN WHERE MOISTURE IS COMING FROM. NOTE THAT THERE IS A SUMP PUMP ON ADJACENT SIDE OF WALL AT EXTERIOR AND THE ROOF WAS LEAKING AT TIME OF INSPECTION ON UPPER FLOOR OVER WATER POOLING IN BASEMENT; FURTHER EVALUATIONS BY A QUALIFIED ROOFER AND/ OR DRAINAGE CONTRACTOR IS RECOMMENDED.**

**12.7** BASEMENT LEAKS WATER/ POOLS AT S.E. CORNER; CONSULT A LICENSED DRAINAGE CONTRACTOR TO REPAIR.

STANDING WATER DETECTED IN S.E. BASEMENT ALONG FOUNDATION WALL. IT IS UNKNOWN WHERE MOISTURE IS COMING FROM. NOTE THAT THERE IS A SUMP PUMP ON ADJACENT SIDE OF WALL AT EXTERIOR AND THE ROOF WAS LEAKING AT TIME OF INSPECTION ON UPPER FLOOR OVER WATER POOLING IN BASEMENT; FURTHER EVALUATIONS BY A QUALIFIED ROOFER AND/ OR DRAINAGE CONTRACTOR IS RECOMMENDED.

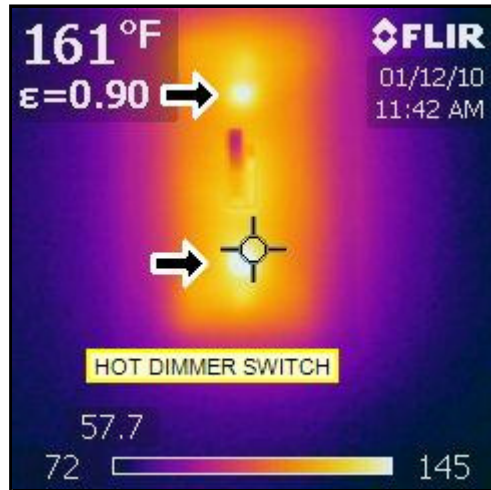
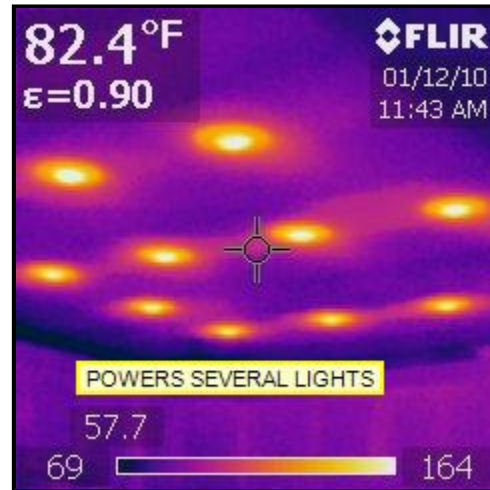
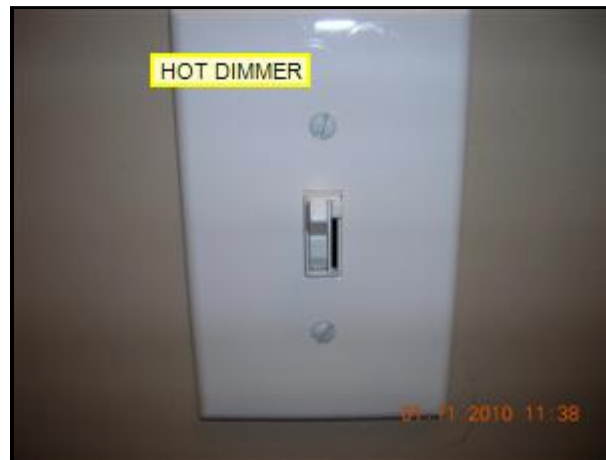
**8.4** DIMMER DEVICE TO KITCHEN CANNED LIGHTS REACHED 160 DEGREES AT COVER PLATE. IT APPEARS THAT THE DEVICE IS ON CIRCUIT OVERLOAD; RECOMMEND A LICENSED ELECTRICIAN TO EVALUATE AND REPAIR/ UPGRADE DIMMER DEVICE AS NEEDED FOR SAFETY.

DIMMER DEVICE TO KITCHEN CANNED LIGHTS REACHED 160 DEGREES AT COVER PLATE. IT APPEARS THAT THE DEVICE IS ON CIRCUIT OVERLOAD; RECOMMEND A LICENSED ELECTRICIAN TO EVALUATE AND REPAIR/ UPGRADE DIMMER DEVICE AS NEEDED FOR SAFETY.

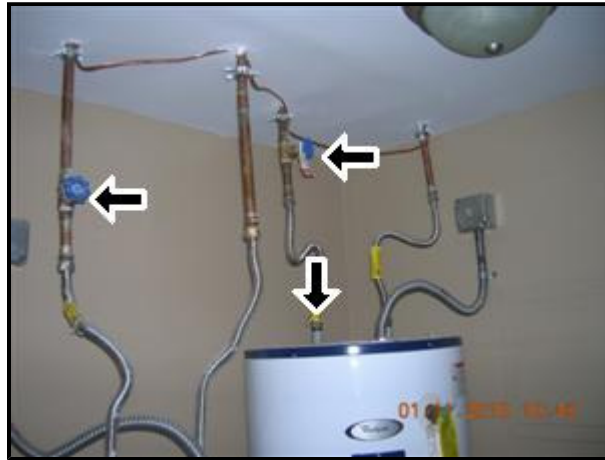
11.1 Picture 1

**11.1 COLD WATER VALVES ARE REVERSED (ON HOT WATER SIDE); INSTALL ON COLD WATER SIDE AT TIME OF NEXT SERVICE.**

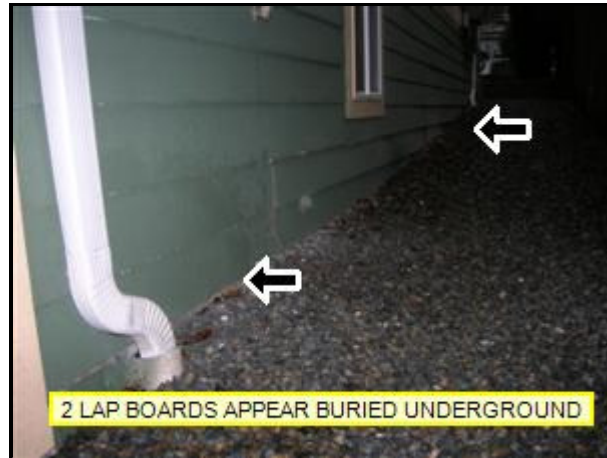
12.2 Picture 1

**12.2** TWO HARDIPLANK (CEMENT) BOARDS AT N.W. AREA APPEAR BURIED IN SOIL. WHILE THIS MATERIAL IS NOT CONSIDERED TO BE PRONE TO DECAY/ROT, THIS IS CONDUCTIVE TO PEST ACTIVITY BEHIND WALL CLAD; RECOMMEND GRADING SOIL 4"-6" BELOW BOTTOM OF SIDING TO REDUCE RISK OF PEST ACTIVITY.

TWO HARDIPLANK (CEMENT) BOARDS AT N.W. AREA APPEAR BURIED IN SOIL. WHILE THIS MATERIAL IS NOT CONSIDERED TO BE PRONE TO DECAY/ROT, THIS IS CONDUCTIVE TO PEST ACTIVITY BEHIND WALL CLAD; RECOMMEND GRADING SOIL 4"-6" BELOW BOTTOM OF SIDING TO REDUCE RISK OF PEST ACTIVITY.
